Great Lakes Beach Conference

Chicago Case Study

Case Study: 63rd St. Beach

Chicago, Illinois

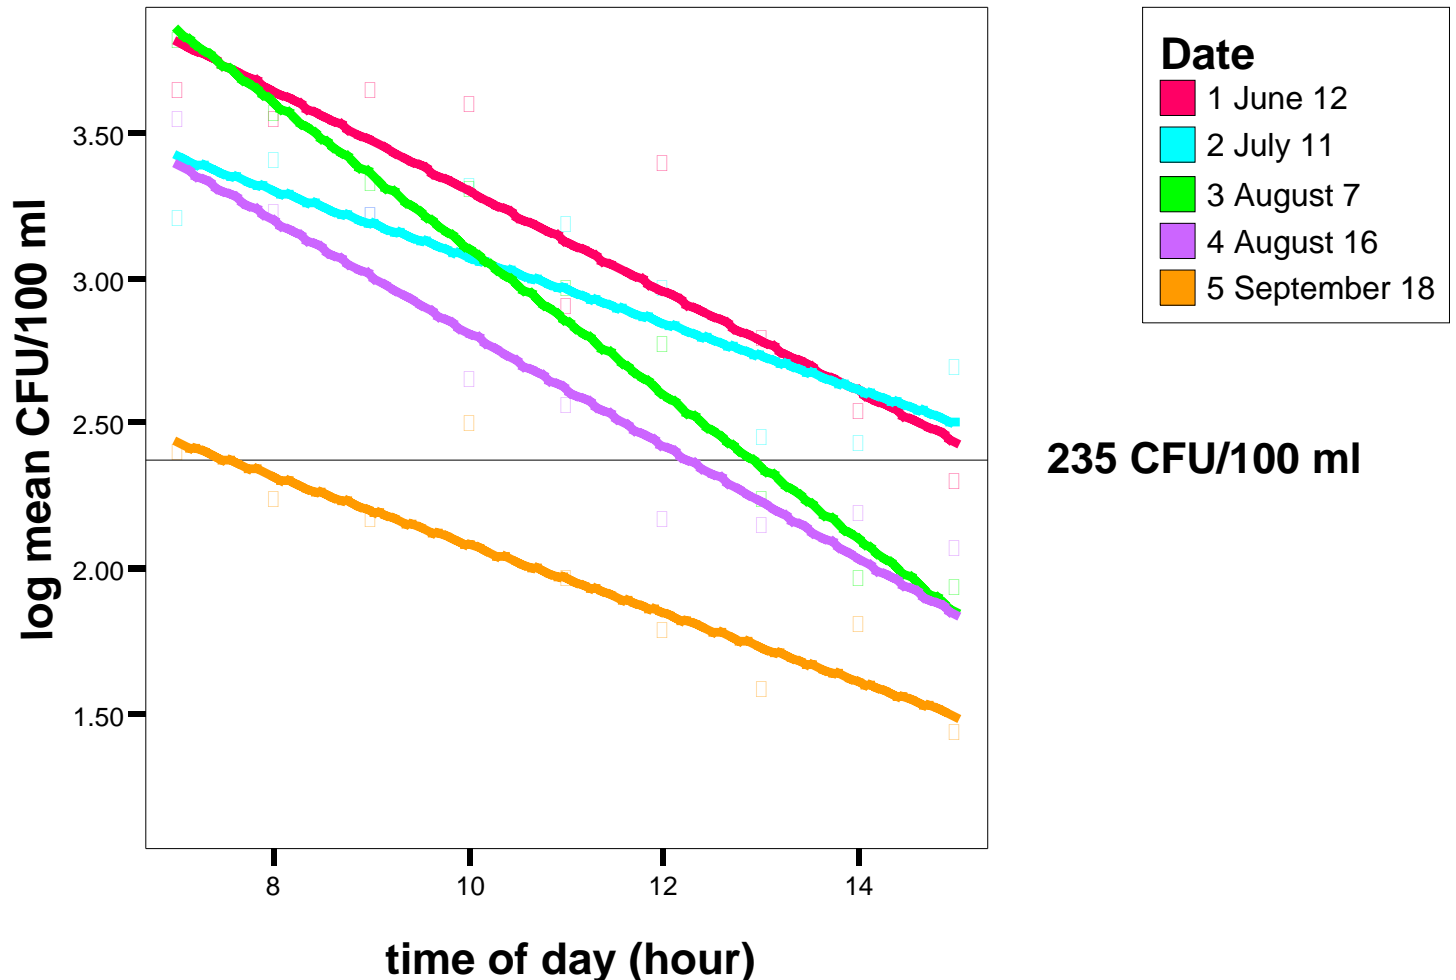
Hourly *E. coli* Concentrations 63rd St. Beach, Chicago, 2000

- **Hourly samples showed a decrease in *E. coli* concentration over the course of day**
- ***E. coli* levels were higher in shallow waters vs. deep, warm waters**
- ***E. coli* reduces with exposure to sunlight**
- **Movement of water is downward into the sand (except swash zone)**
 - ***E. coli* in swash zone & water movement may be a link between resident sand *E. coli* populations & water contamination**
- **Correlation among *E. coli* levels, storm events, & associated high winds & waves**

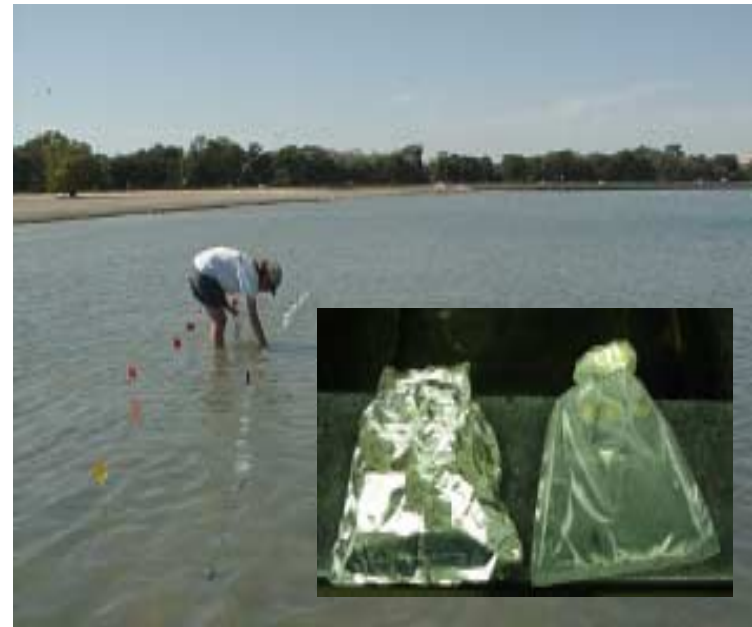
Results of Light/Dark Bag Experiment

63rd St. Beach, Chicago

September 18, 2000

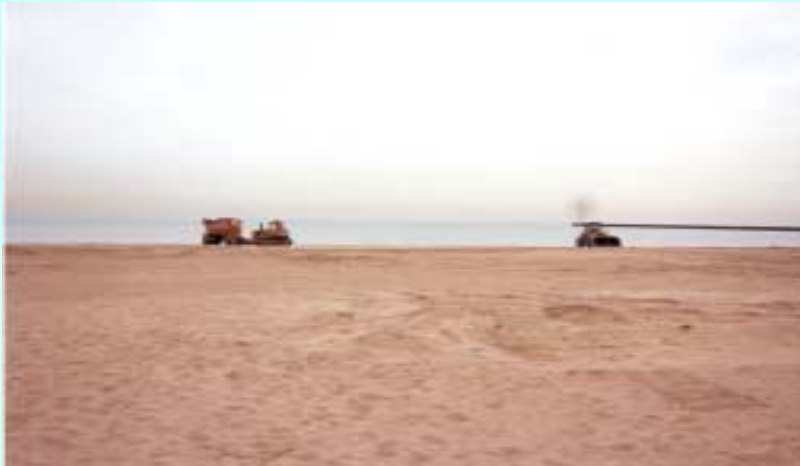
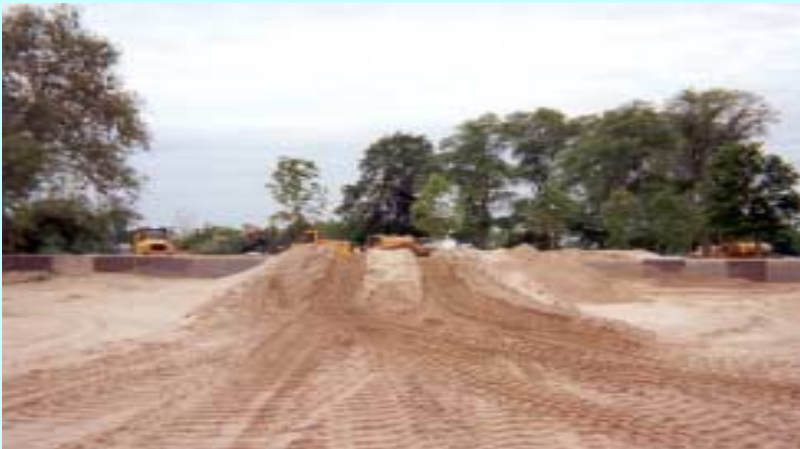
- Sand removal & replacement
 - May 2000
 - Top 6 inches

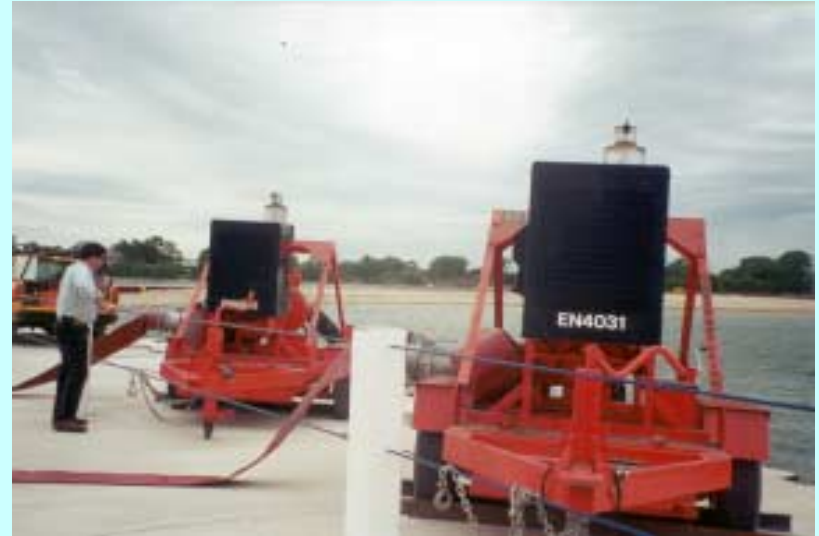
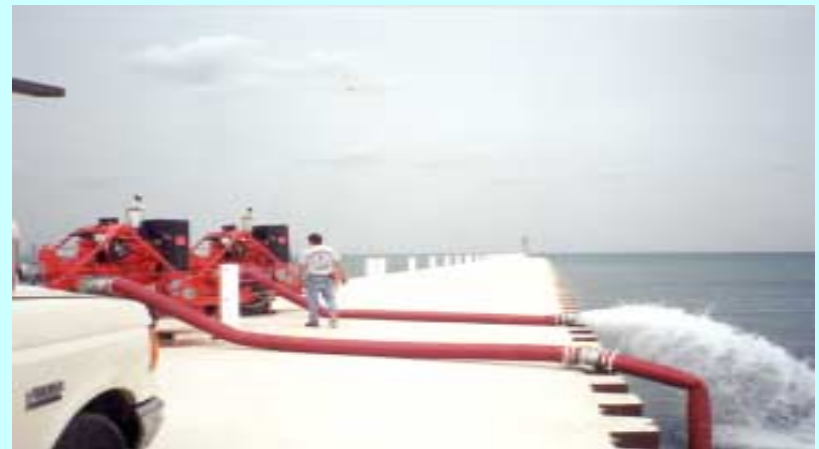
- Temporary pumps installed
 - August 2000
 - Increase circulation

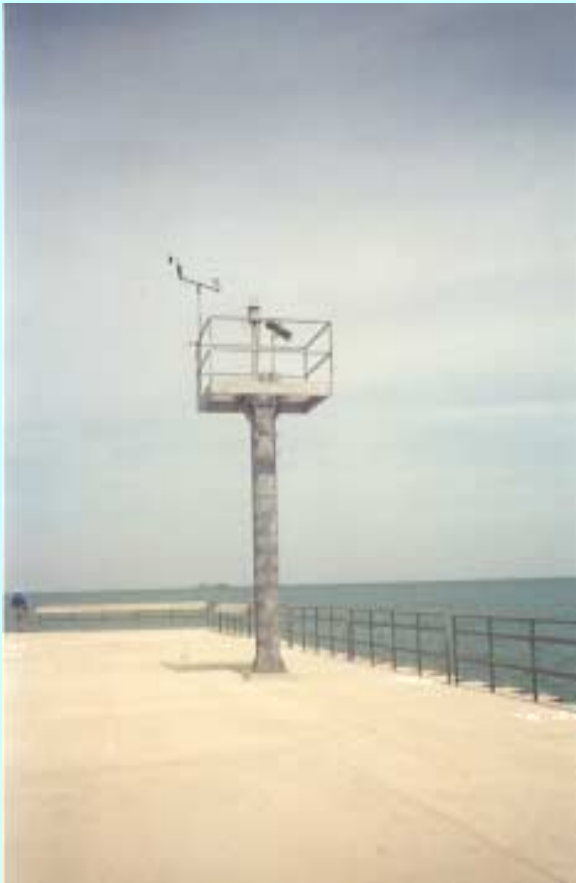
- Equipment installed for monitoring physical & chemical properties of beach water
 - Weather station (wind speed, wind direction, temperature, rainfall, etc.)
 - Doppler flow meter (measures flow of surface water in/out of lagoon)
 - YSI probes with datalogger (dissolved oxygen, pH, turbidity, etc.) reading every 15 minutes

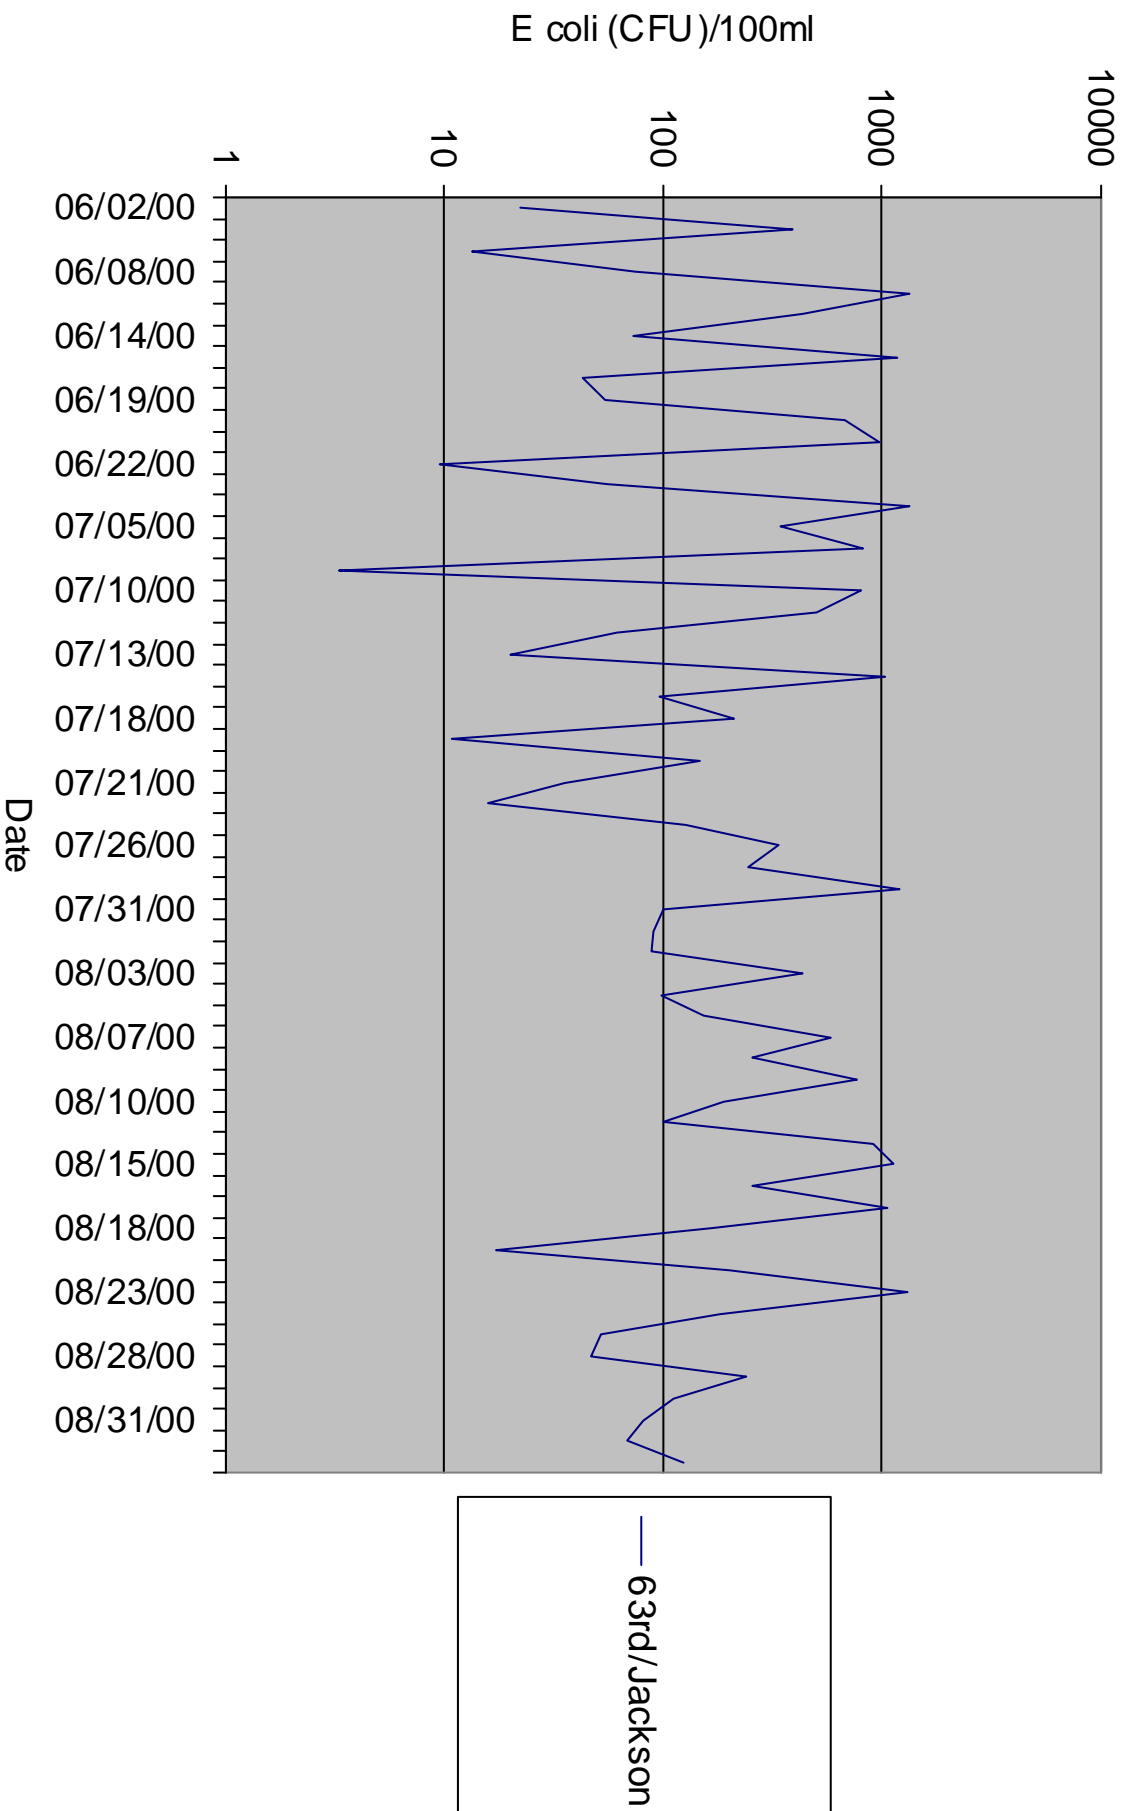
Summer 2000 *E. coli* Concentrations, 63rd St. Beach

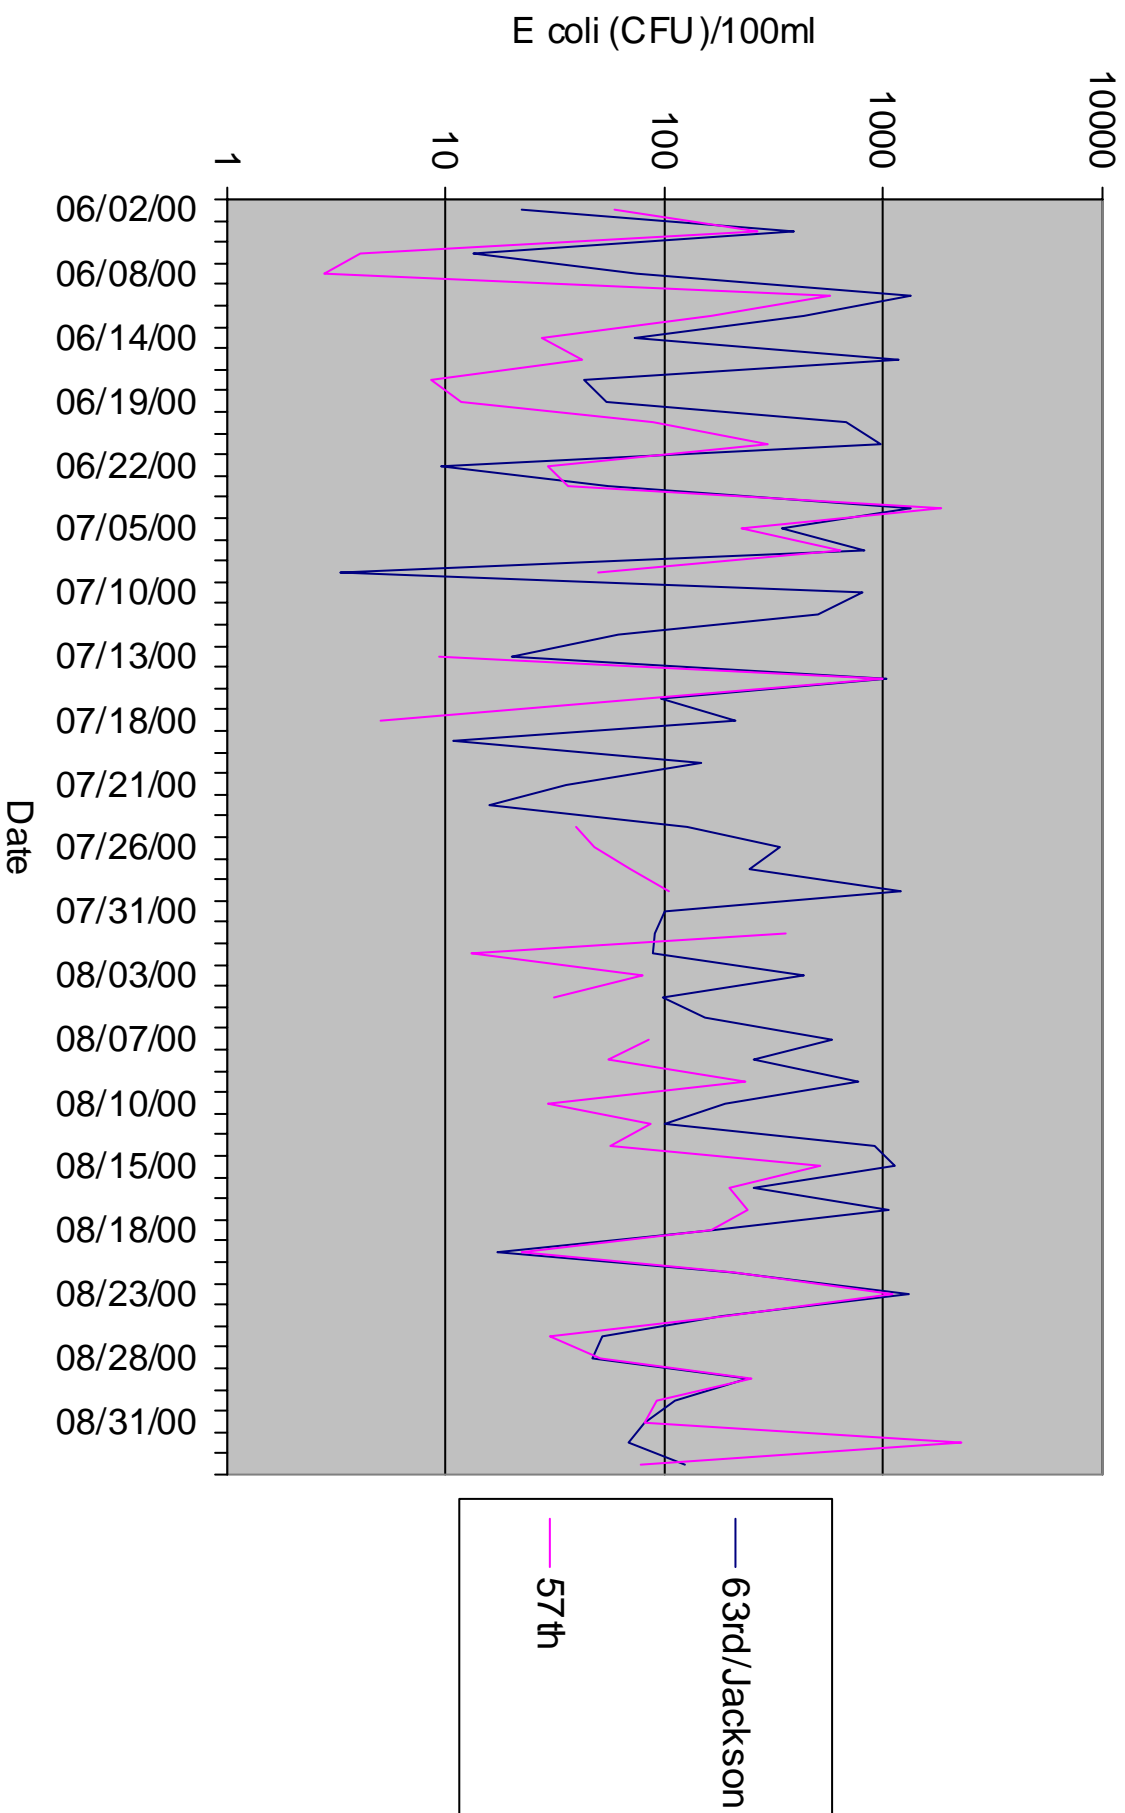
Summer 2000 *E. coli* Concentrations, 63rd St. & Adjacent Beaches

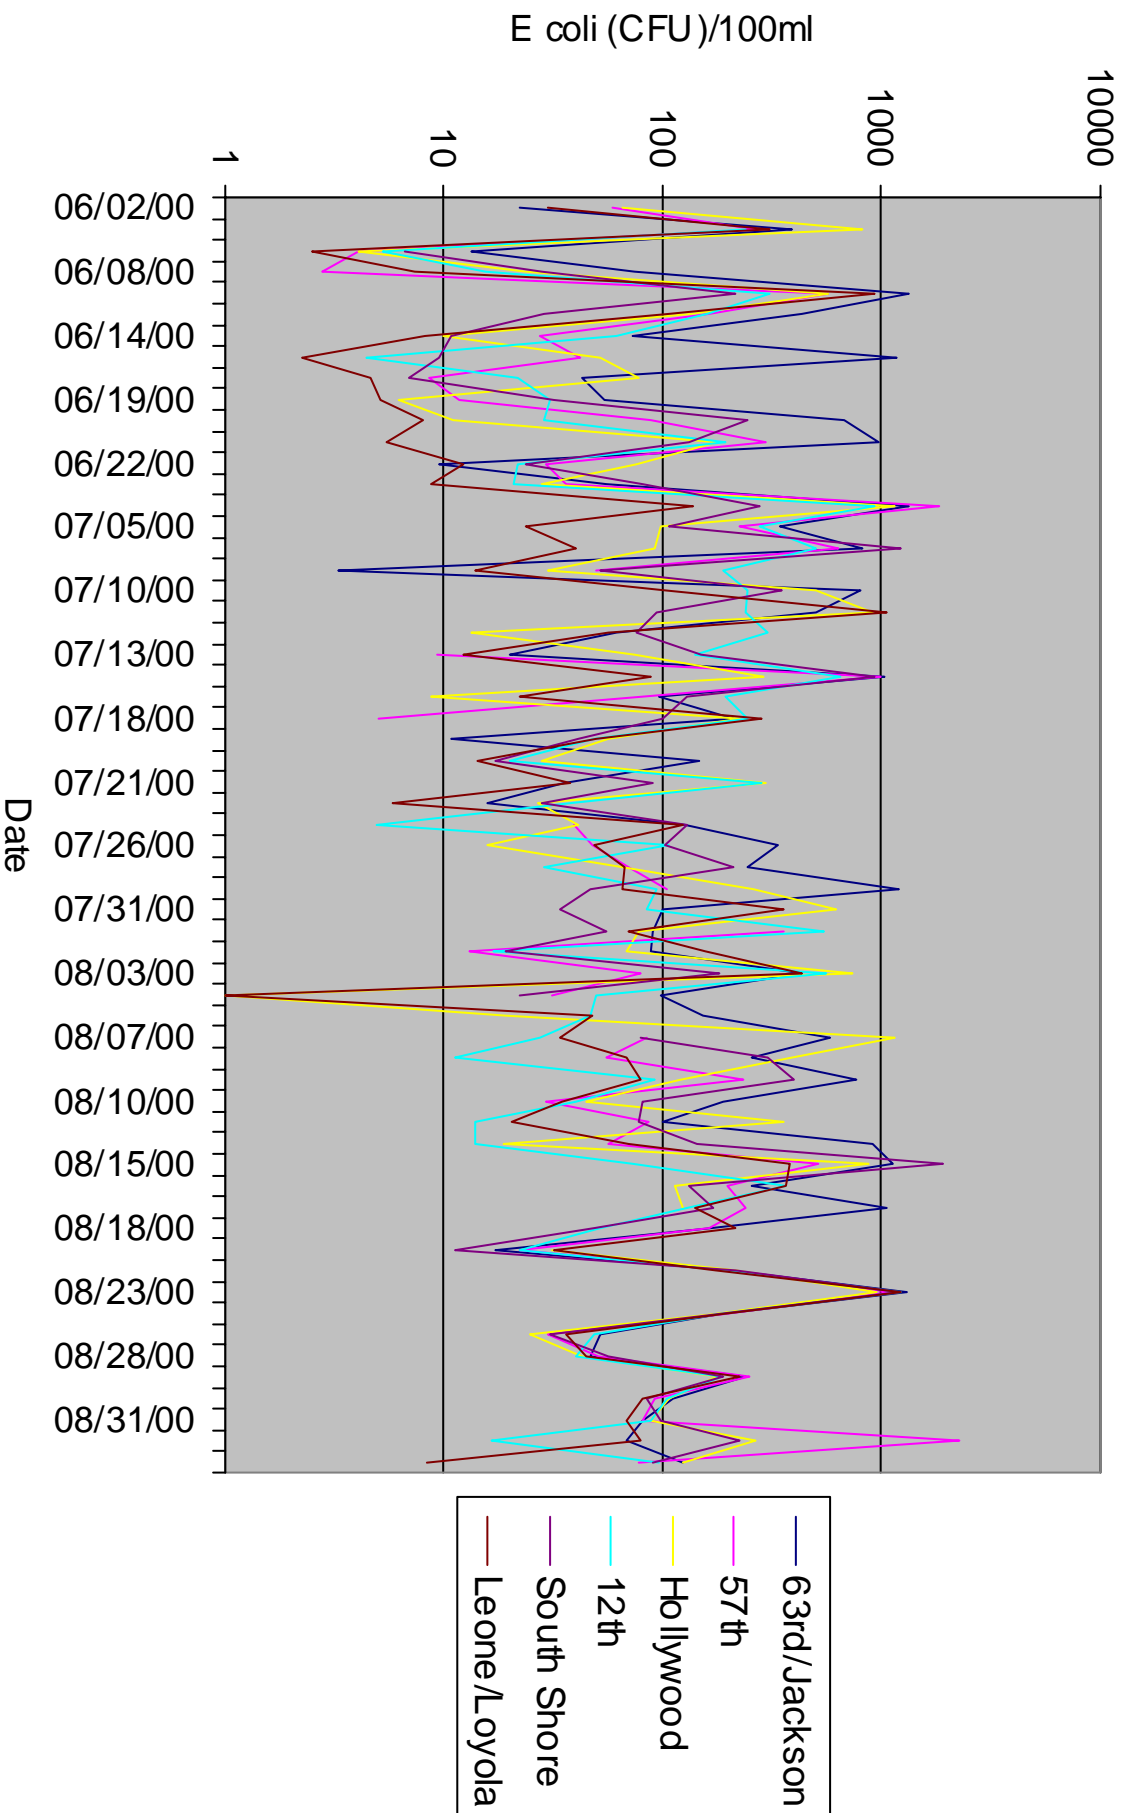
Summer 2000 *E. coli* Concentrations, 63rd St. & Adjacent Beaches
